ENGINEERING CONDITION SURVEY AND
EVALUATION OF TROY LOCK AND DAM
HUDSON RIVER, NEW YORK

ENGINEERING CONDITION SURVEY,

Carl E. Pace

May 1978

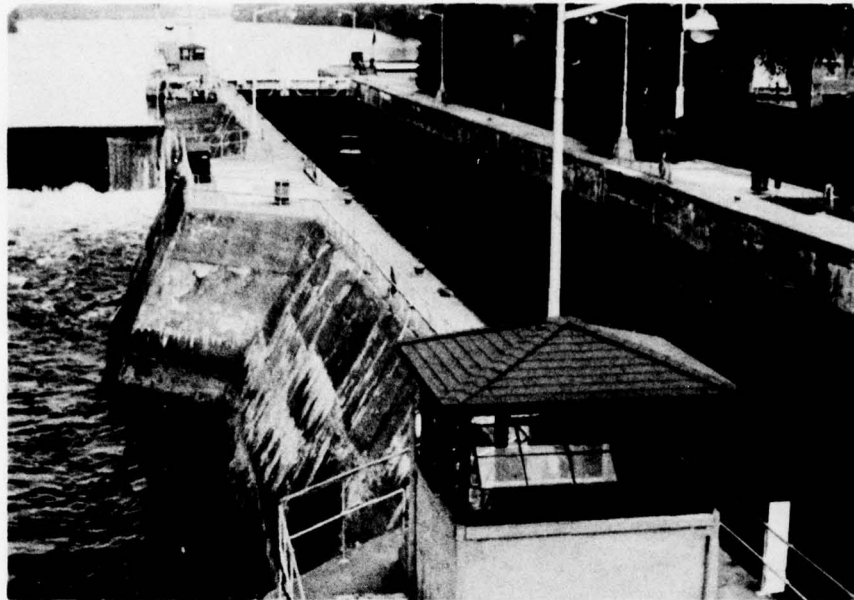
24. The surface condition of the lock, dam, and spillway section is in the advanced stage of deterioration. Figures 2.6 and 2.7 give an overall view of the lock, dam, and powerhouse. Figure 2.6 (from bottom to top of page) views the lower miter gate, powerhouse, general configuration of the land wall, river wall, and the beginning of the dam from the lock

Figure 2.6 Overview of lock (bottom to top of page) looking upstream.

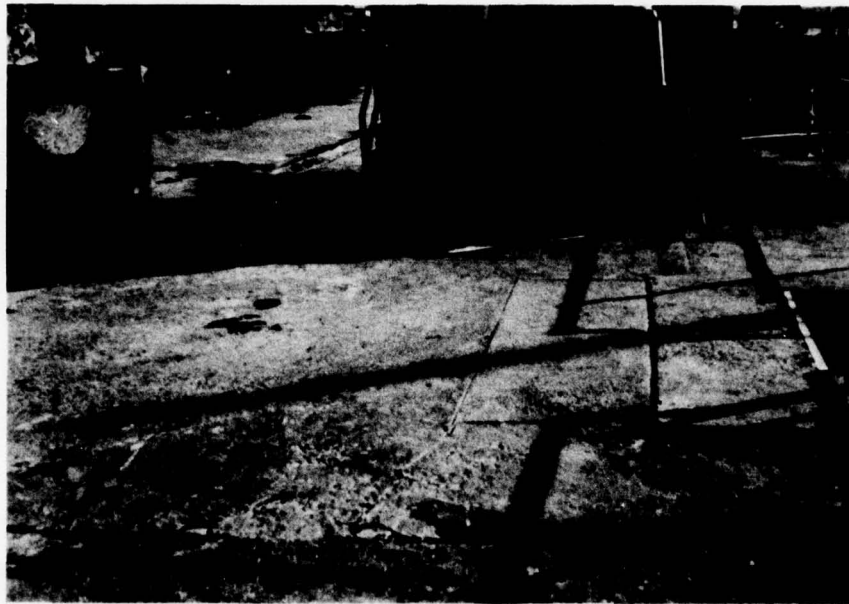
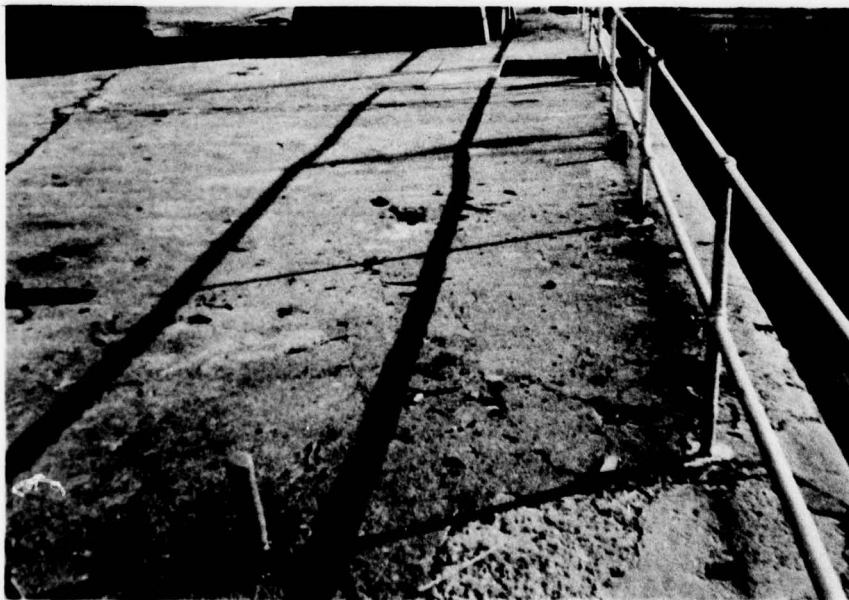
25. The deterioration of the concrete surface of the land wall monoliths is not as bad as that of the river wall. A sequence of pictures shown in Figures 2.8 through 2.16 starts upstream and progresses downstream showing the deteriorated top concrete surface of the land wall. The location of these views is also presented in Figure 2.1. As can be seen, there is spalling and cracking of the concrete surface. Most of the surface has been patched or overlayed with newer concrete; therefore, the spalling and cracking are of the concrete overlays. These cracks may or may not extend into the original monolith. As has been stated earlier, the cracking is not significant in the top surface of the land wall and the deteriorated concrete surface just needs maintenance. There is no indication of misalignment, settlement, or critical stress problems in either the land or river wall monoliths.

Figure 2.8 Landwall--upstream of upper miter gate
viewing downstream.

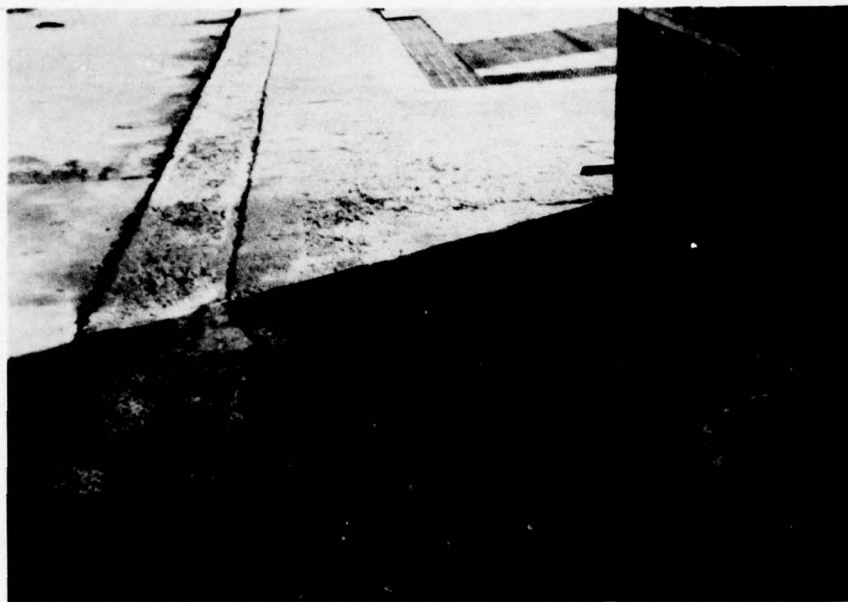
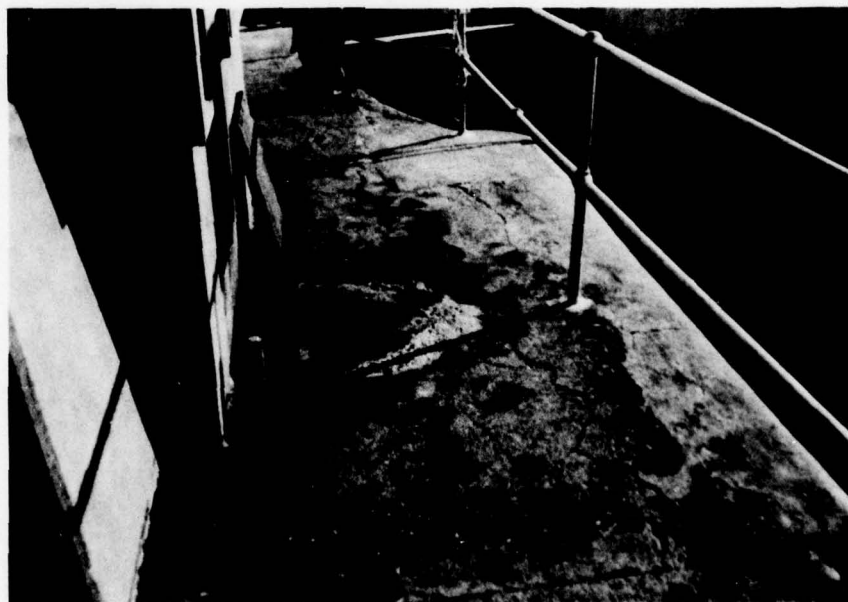
Figure 2.9 Landwall--just upstream and to either side of operating station viewing downstream.

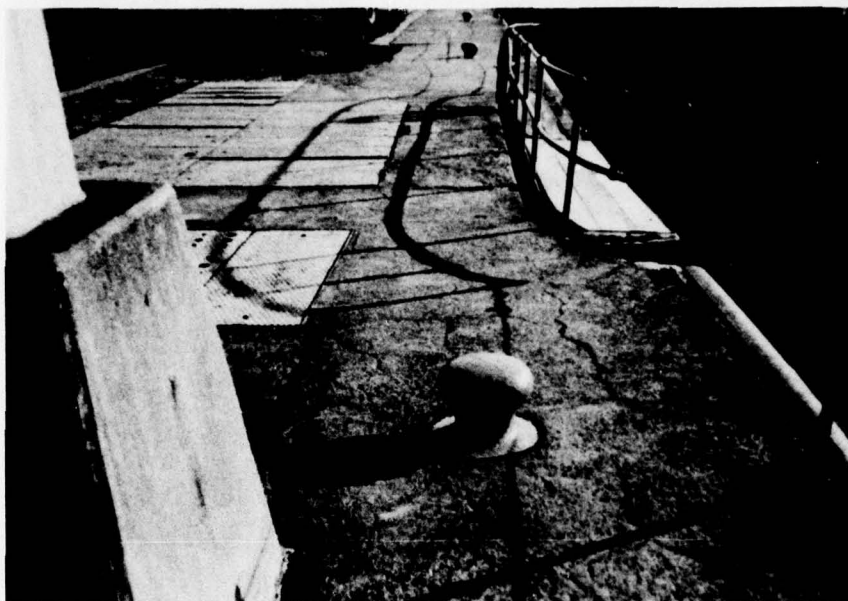
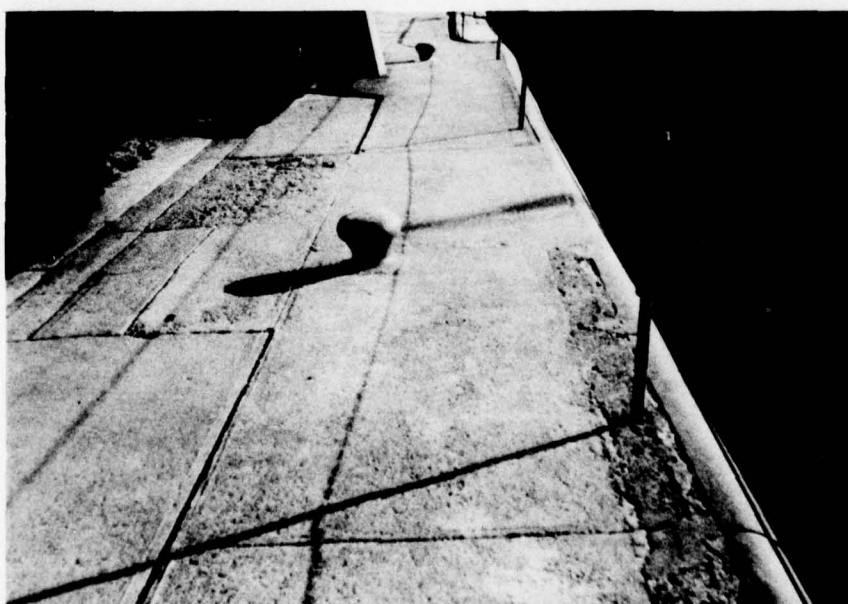
Figure 2.10 Landwall--view just upstream (bottom), then downstream (top) of upper miter gate.

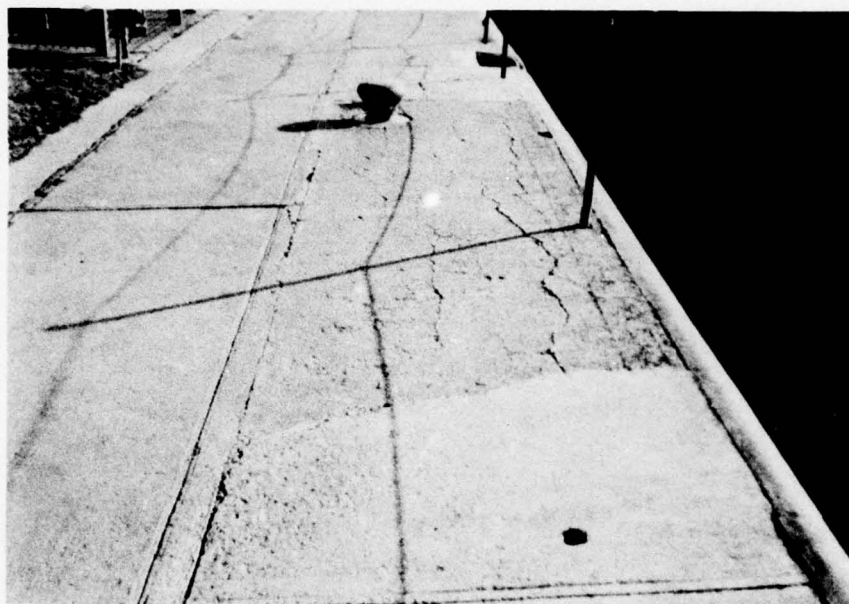
Figure 2.11 Landwall--downstream of upper miter gate but upstream of middle gate.

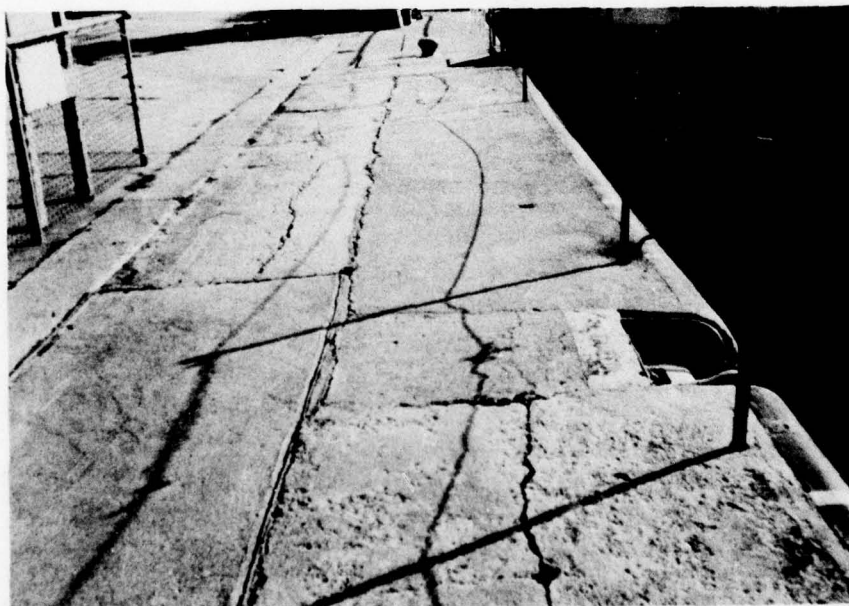
Figure 2.12 Landwall--at middle gate (bottom),
below middle gate (top).

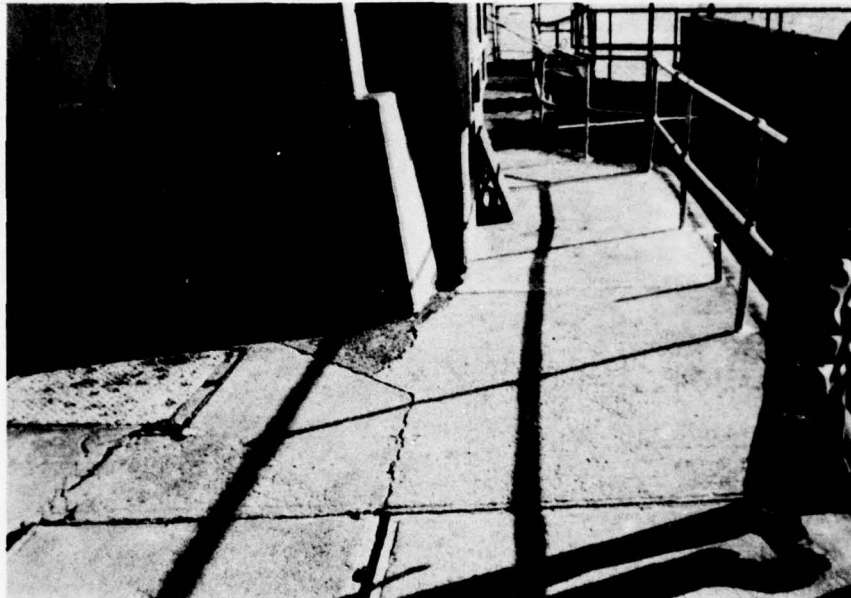
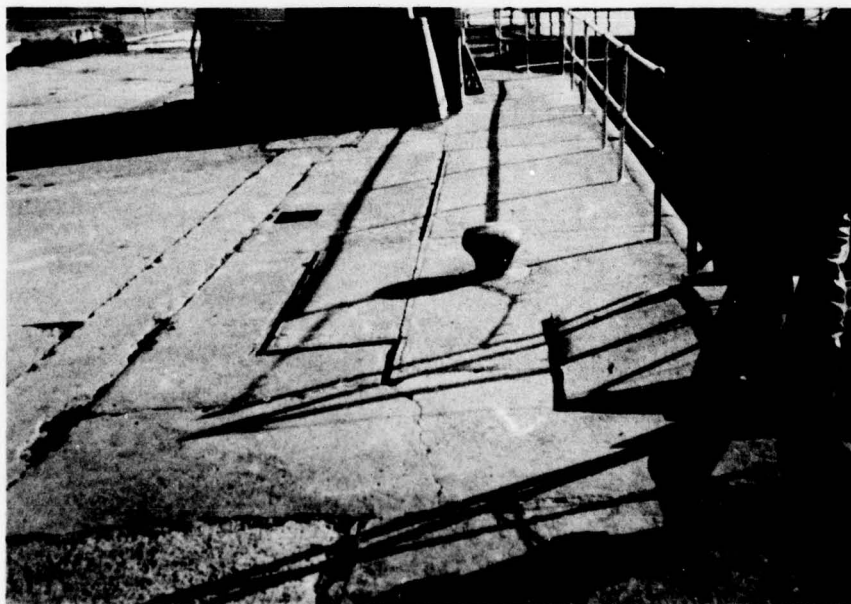
Figure 2.13 Landwall--upstream of lower miter gate.

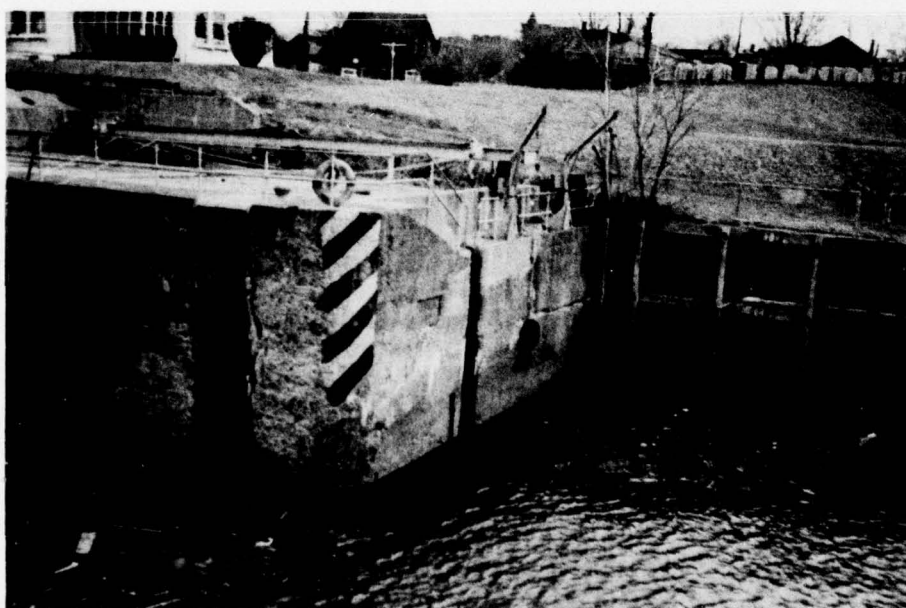
Figure 2.15 Landwall--at lower miter gate.

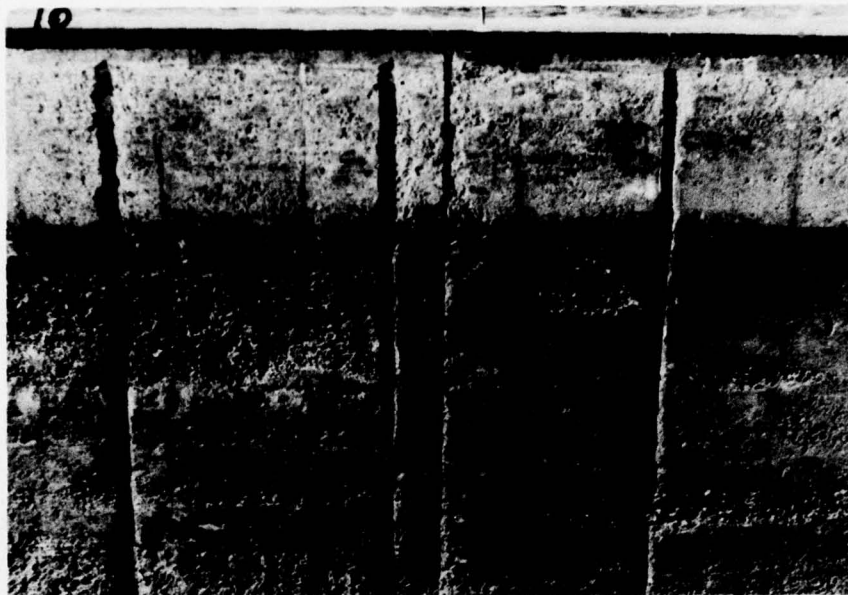
27. The construction joints of the land wall monoliths, as seen from the lock chamber, look tight. The lock walls show some gouging (Figure 2.19) from barge impact, but it is not too extensive. Besides the abrasion, the lock walls are of sound concrete and are in good shape.

Figure 2.18 Typical view of lock chamber walls, bottom to top of page views land-wall then riverwall.

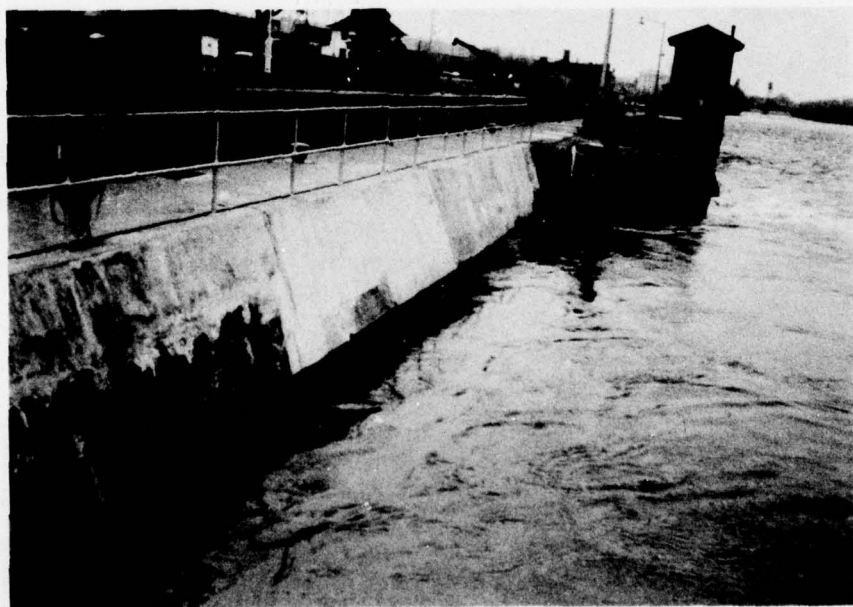
Figure 2.26 Riverwall--surface concrete deterioration at the first operating station upstream of upper miter gate.

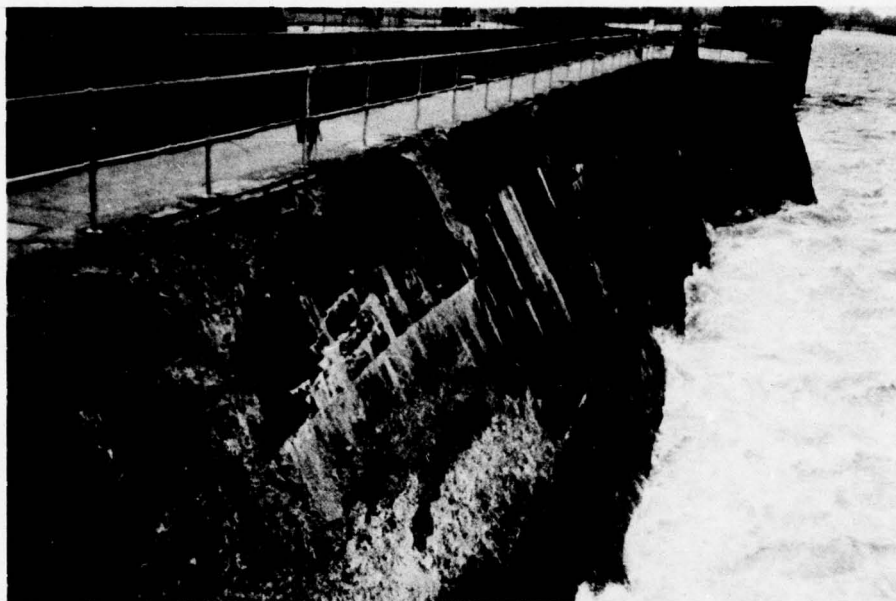
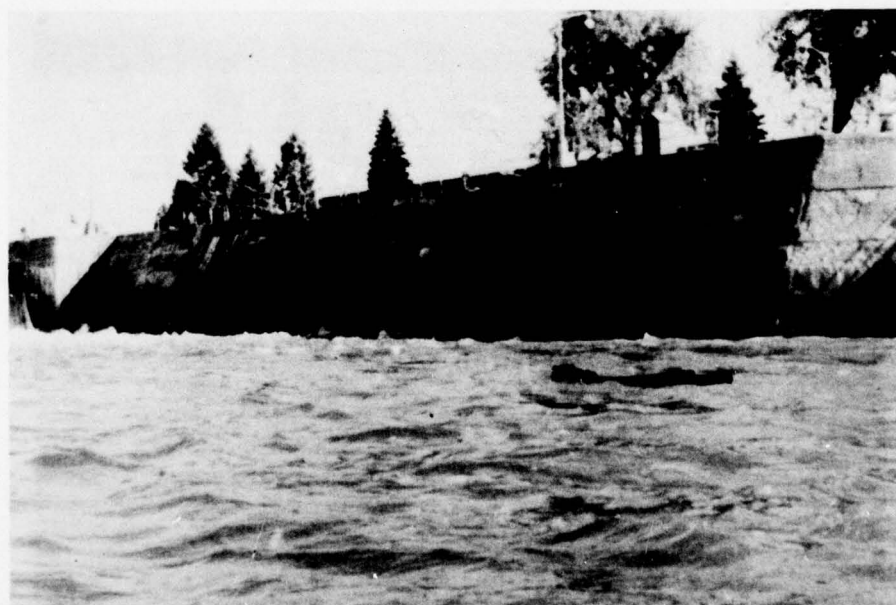
Figure 2.28 Riverwall--location where dams join riverwall.

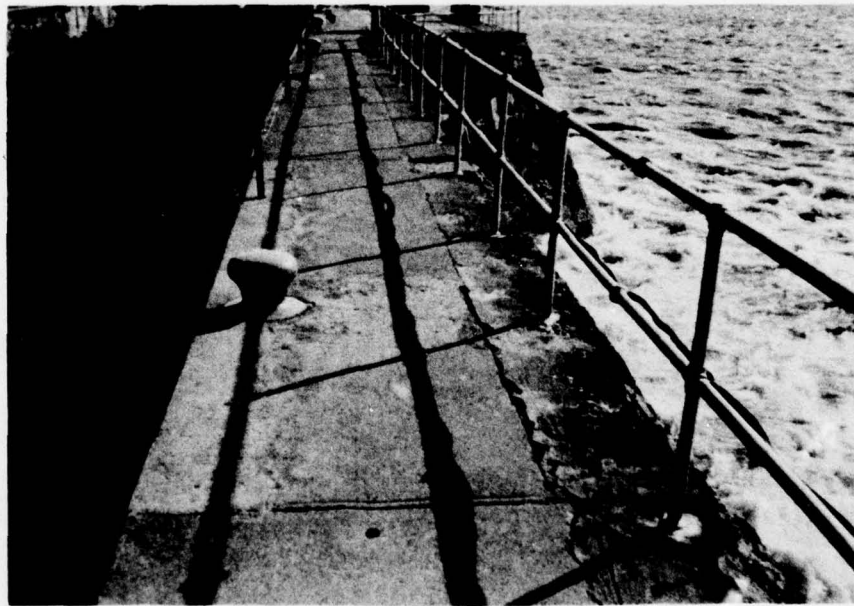
Figure 2.29 Riverwall---just downstream of intersection of dam to riverwall (bottom, looking upstream) and viewing the same wall downstream (top).

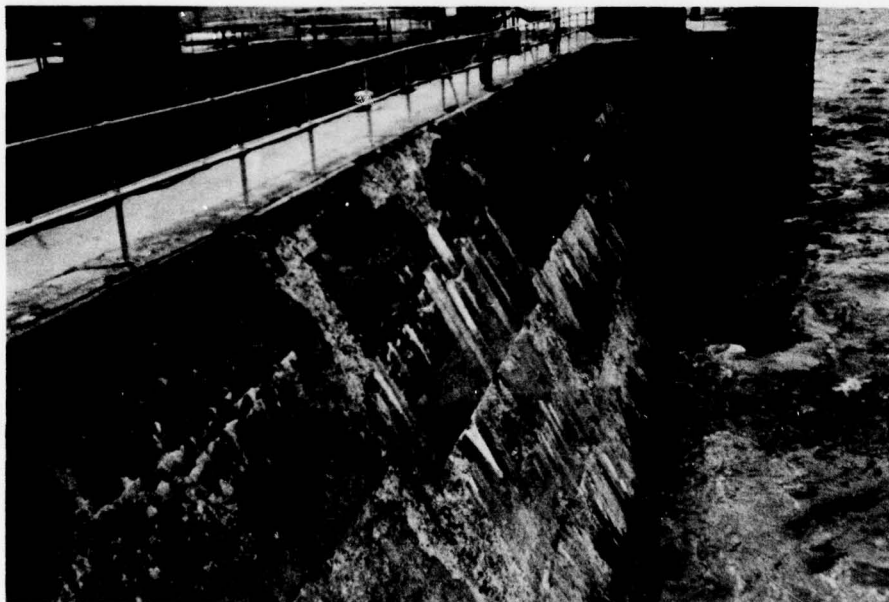
Figure 2.31 Riverwall--just upstream of operation building.

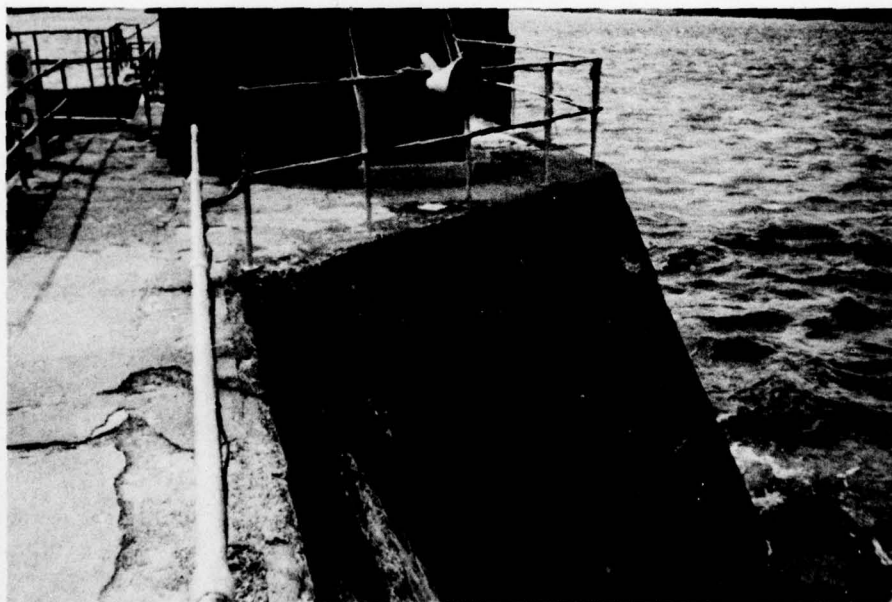
Figure 2.32 Riverwall--just above (bottom) and below (top) operation building.
